CITY OF BOSTON
BOSTON, MASSACHUSETTS

REPORT
OF
INVESTIGATION OF COLLAPSE
AT
HOTEL VENDOME

AUGUST, 1972

SUBJECT: Investigation of Collapse
at Hotel Vendome

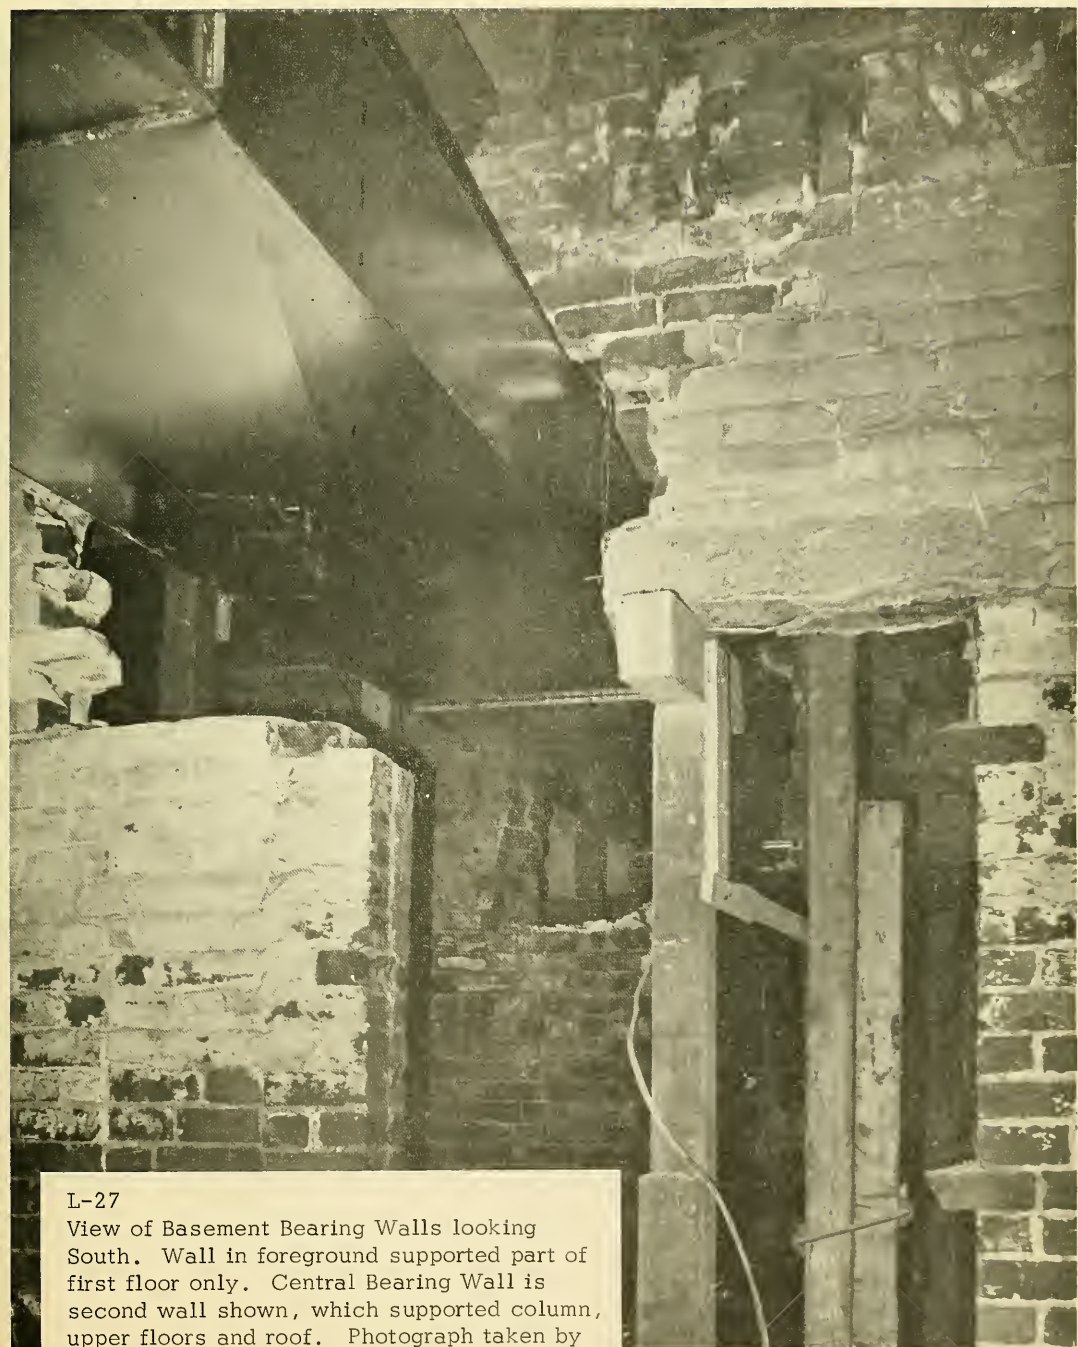
L-27

View of Basement Bearing Walls looking South. Wall in foreground supported part of first floor only. Central Bearing Wall is second wall shown, which supported column, upper floors and roof. Photograph taken by LeMessurier Associates in 1971.
